Evaluation of Ultra High Molecular Weight (UHMW) Polyethylene Panels for Aircraft Arresting Systems

E. Ray Brown

August 2009

Final report

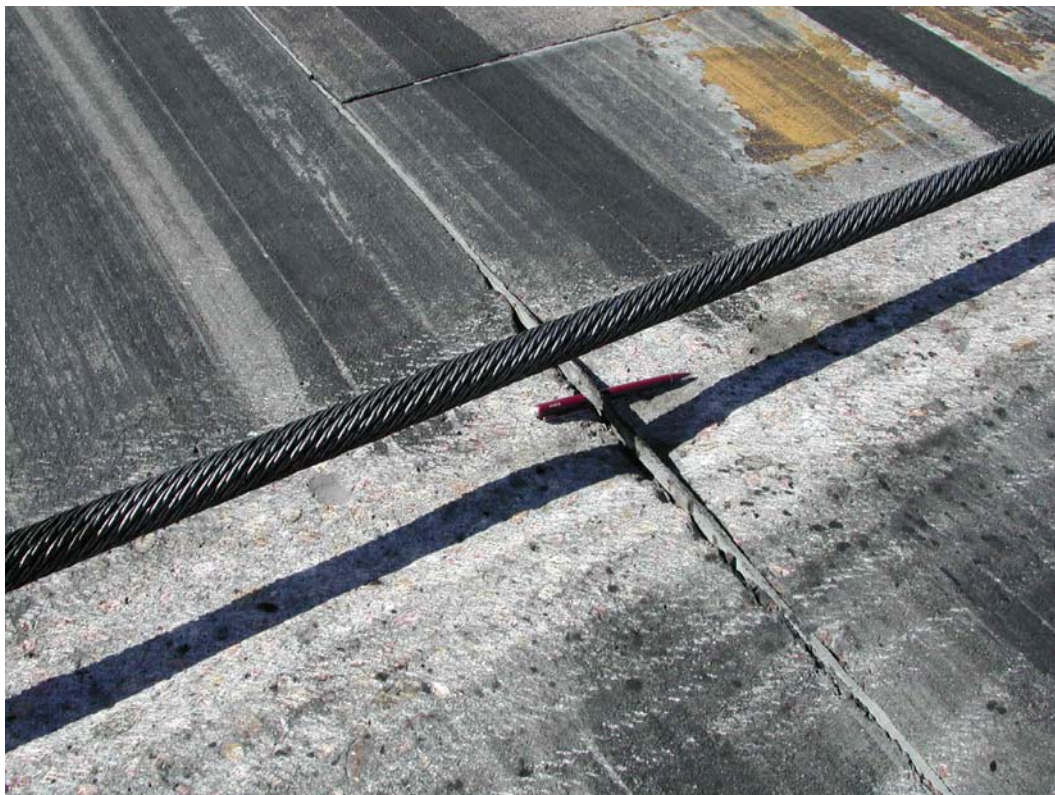
Figure 1. Early cable damage to concrete pavement.

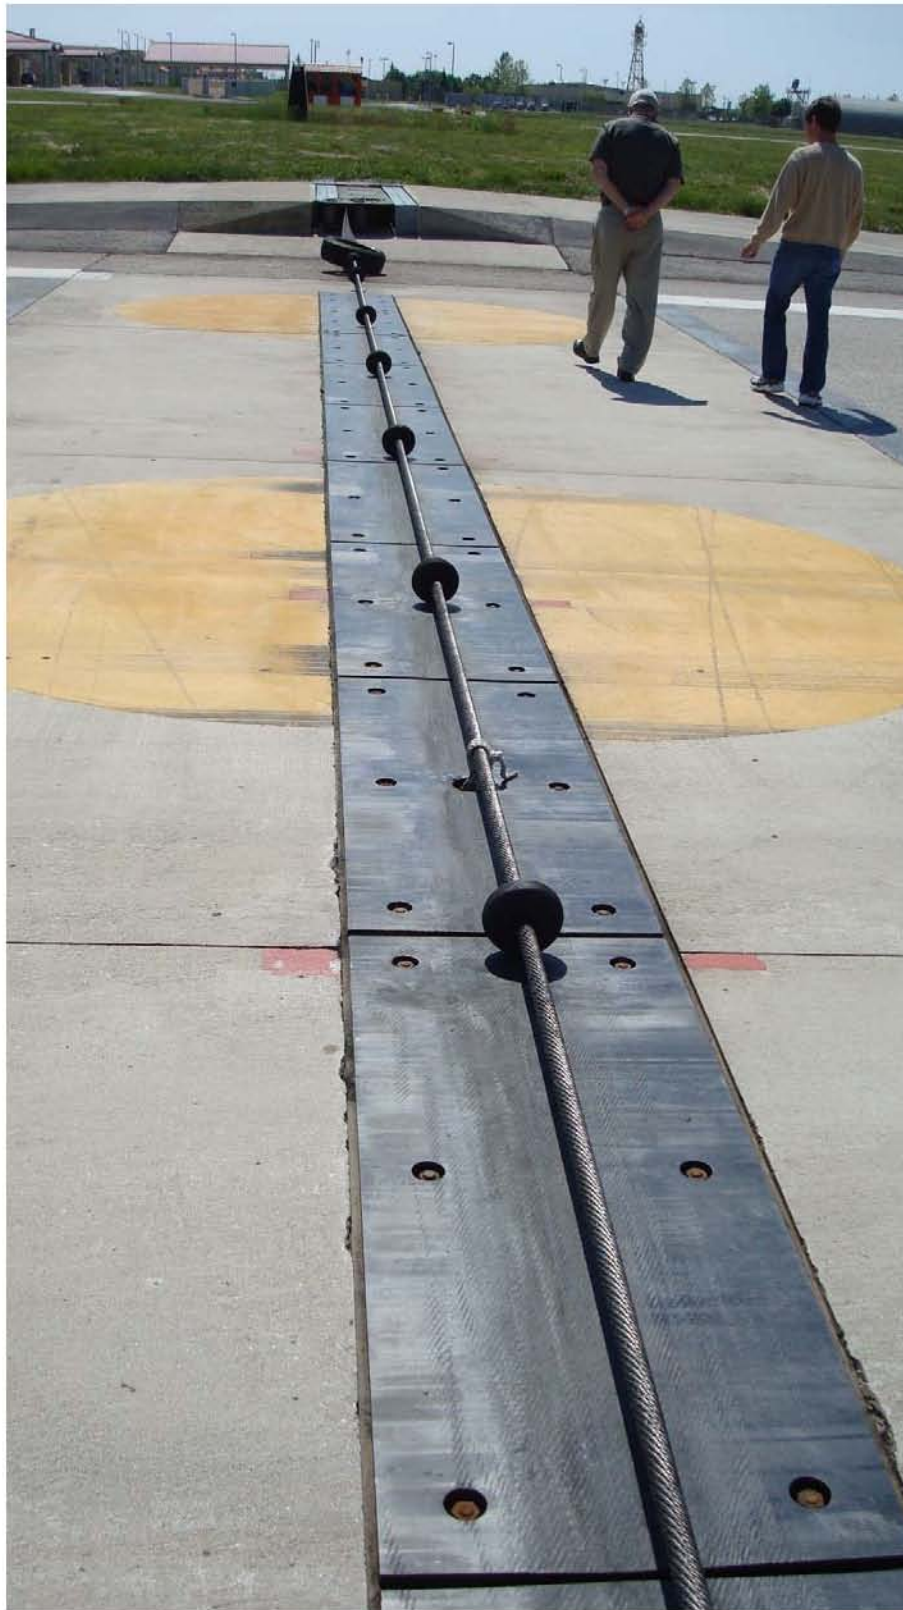
There was some noticeable scarring of the polyethylene panels near the middle of the runway, where most of the traffic passed over the cable. The

Figure 4. UHMW polyethylene panels at Aviano AB.

repeated beating of the cable over the panels eventually led to this scarring, which appears to be very minor. This damage was typical of that seen on a number of projects. However, the panels still appeared to be in good overall shape (Figure 8).

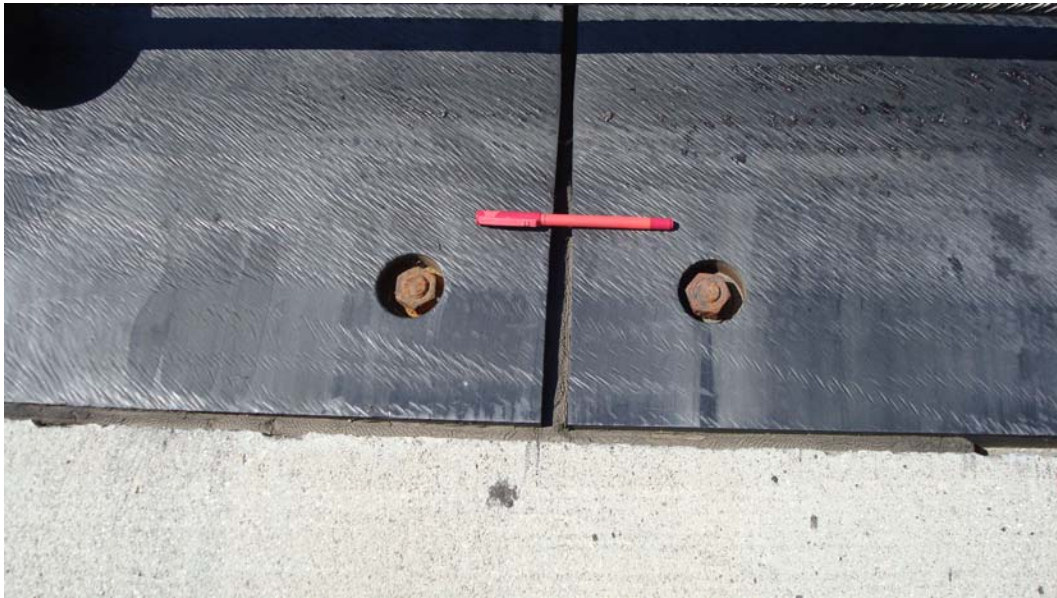
Figure 8. Sealant in poor shape adjacent to panels at Aviano AB.

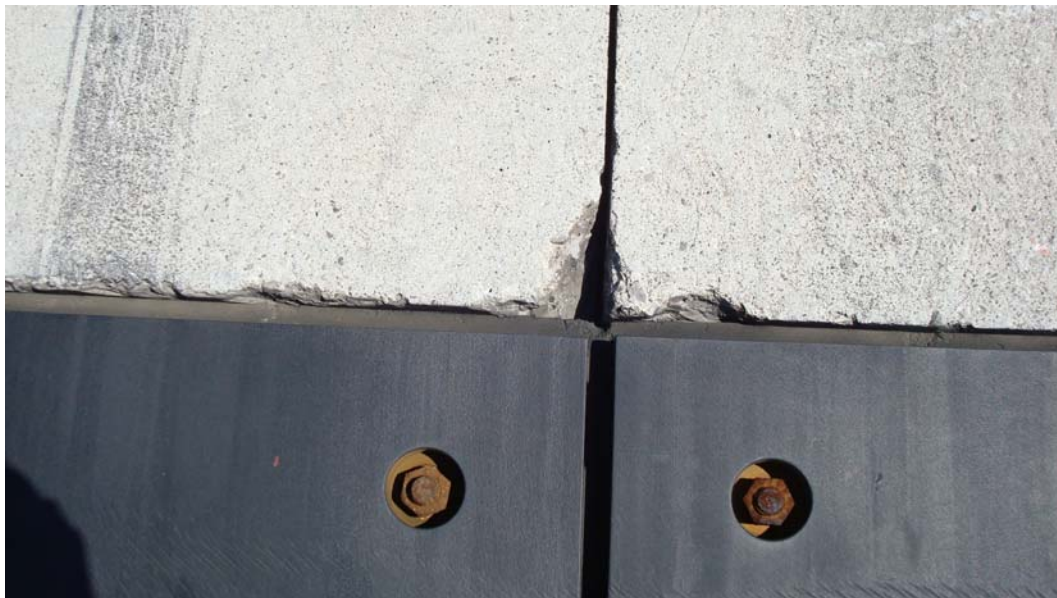
Figure 9. Some spalling of concrete adjacent to panels and at contraction joint at Aviano AB.

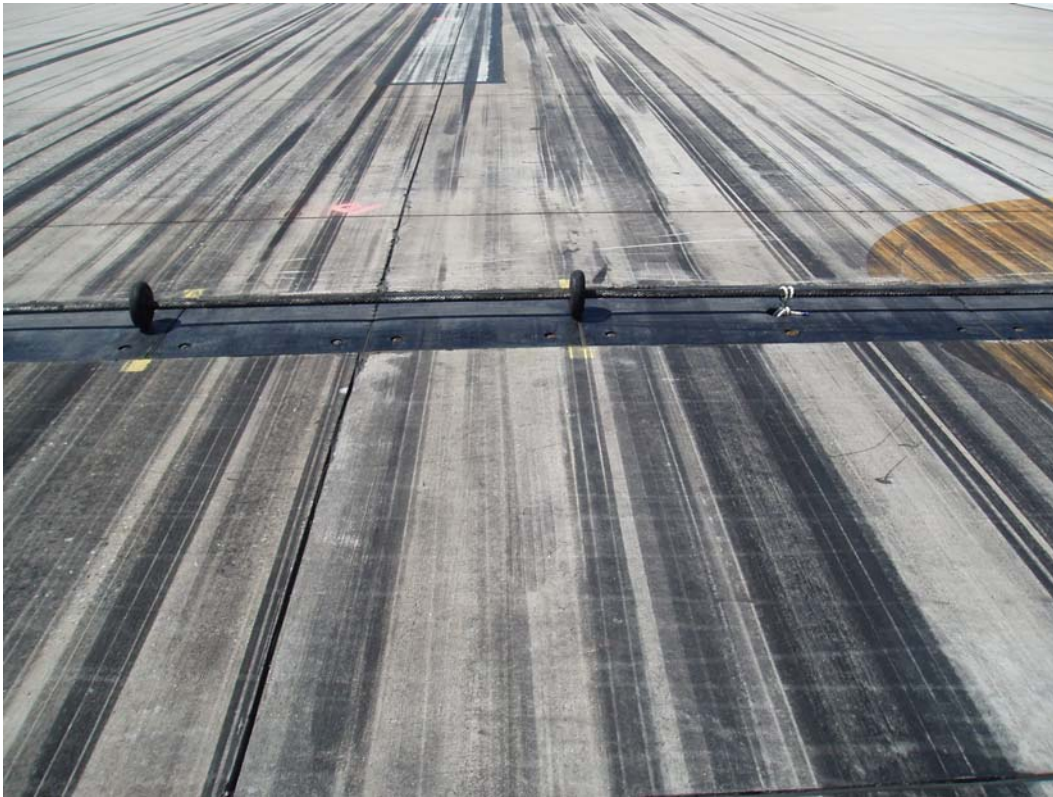
Figure 13. Joint between panels match joint in concrete for panels at Buckley AFB.

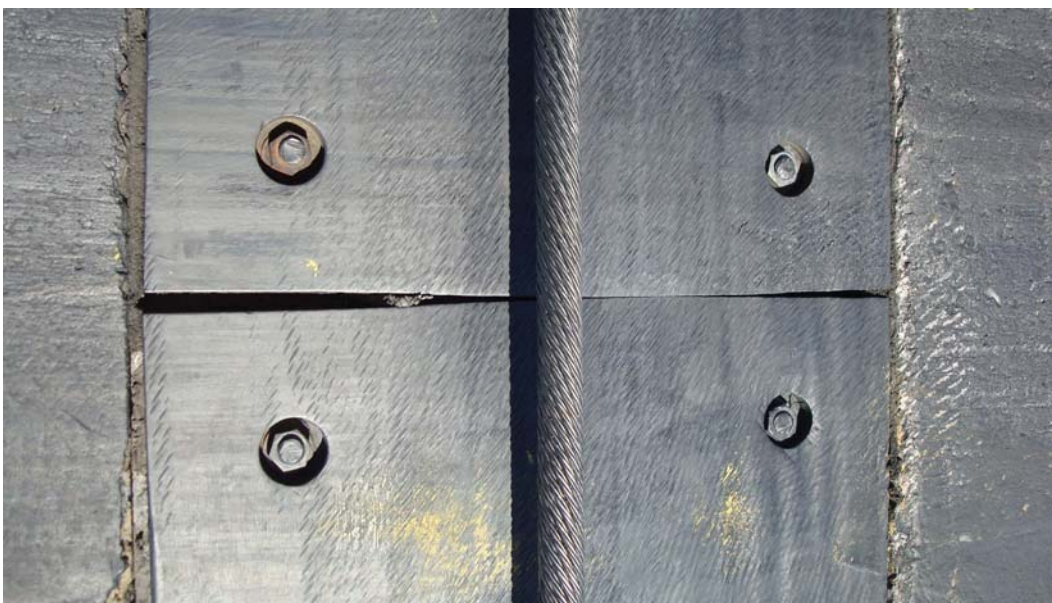
Some of the joints in the polyethylene panels had uneven widths (Figure 15). It is likely that this was caused by temperature and warping effects as well as the beating of the cable on the surface of the panel. It is also possible that the anchors held the panel in place, not allowing it to move immediately adjacent to the anchors, thus resulting in the partial closing of the joint during hot weather in between the anchors but not at

Figure 15. Variable width of joints in polyethylene panels at Davis-Monthan AFB.

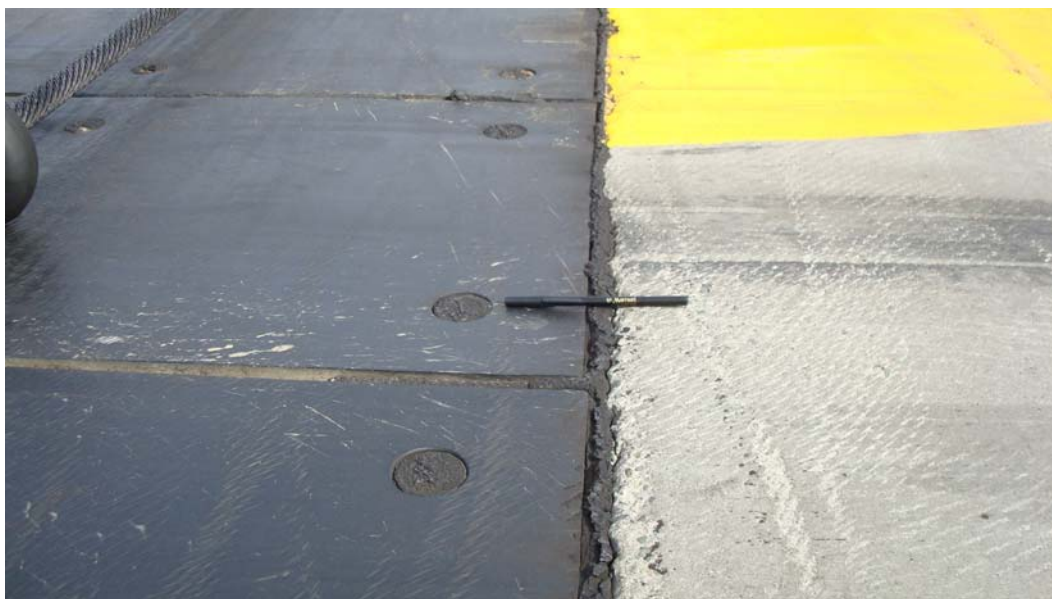
Figure 36. Poor performance of sealer between two adjacent panels and between the panels and the adjacent concrete on Runway 24 at Elmendorf AFB.

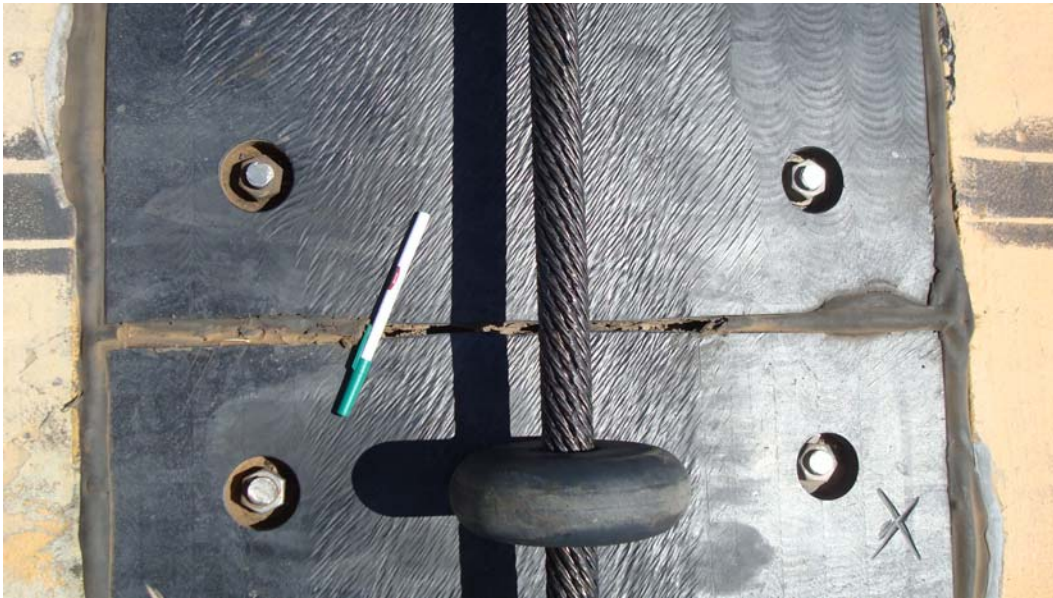
The original sealant was placed when the panels were installed 5 years prior to inspection, and only some small amount of additional sealer was applied to localized areas.

Figure 56. Condition of sealer satisfactory in spots and damaged in other areas at Luke AFB.

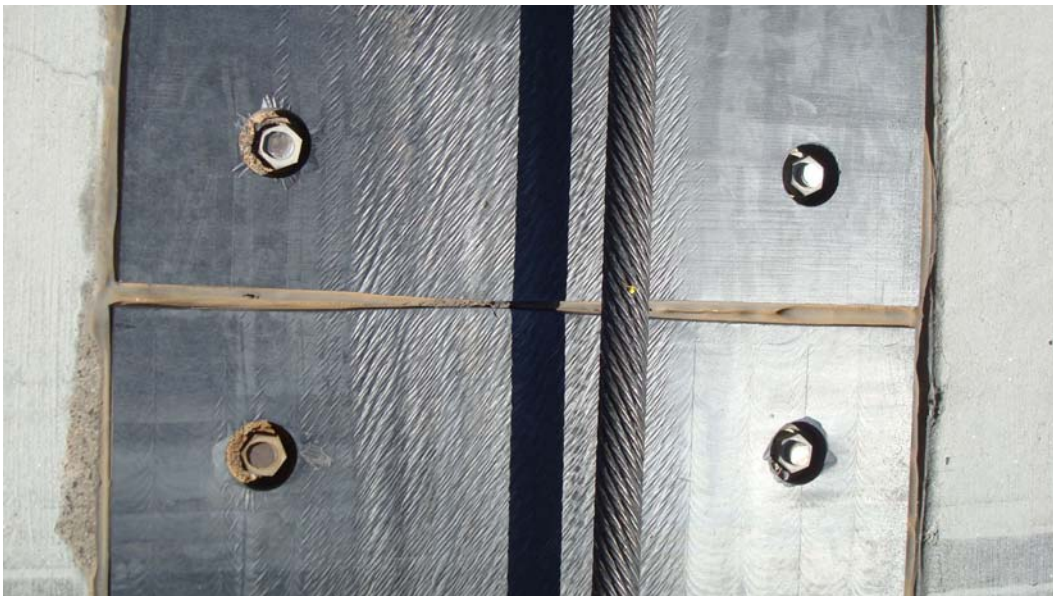
Figure 57. Some deformation in the panels and some wear from beating of the cable at Luke AFB.

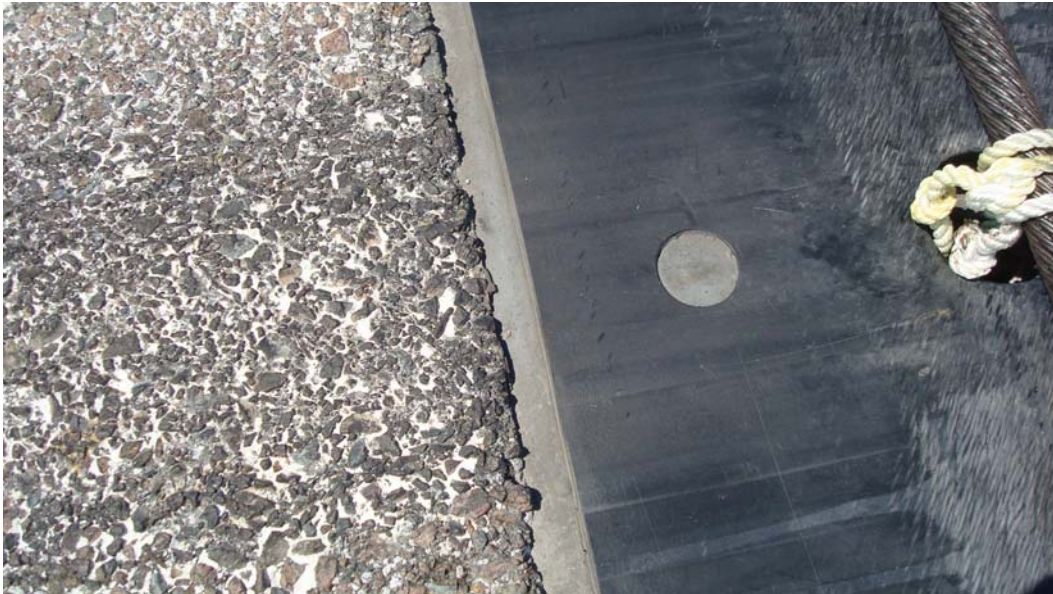
Figure 59. Condition of sealant after 3 months in place at MacDill AFB.

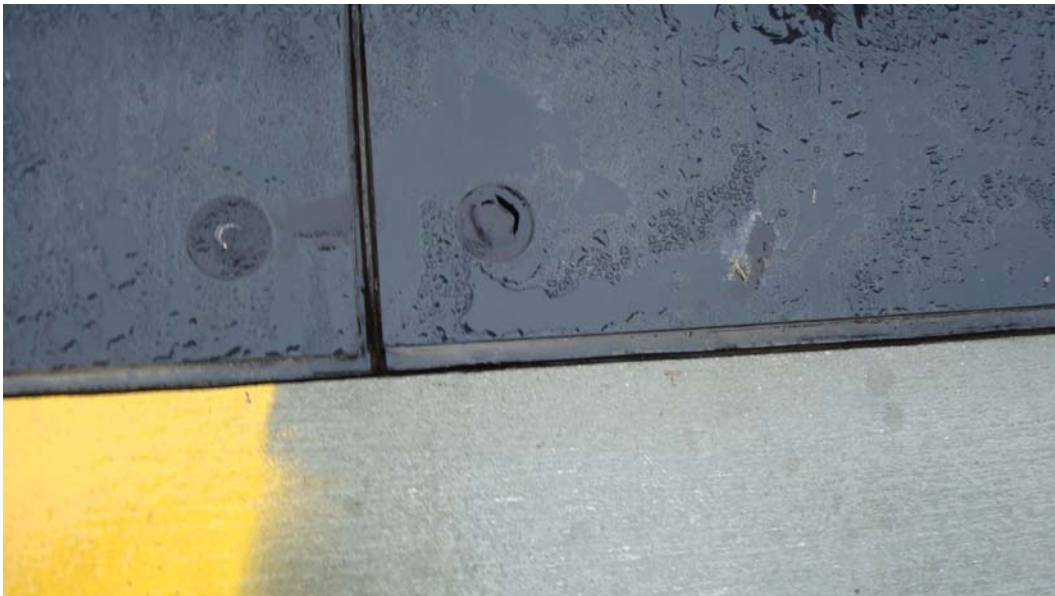
Figure 67. Performance of sealant at Runway 22 R at Shaw AFB.

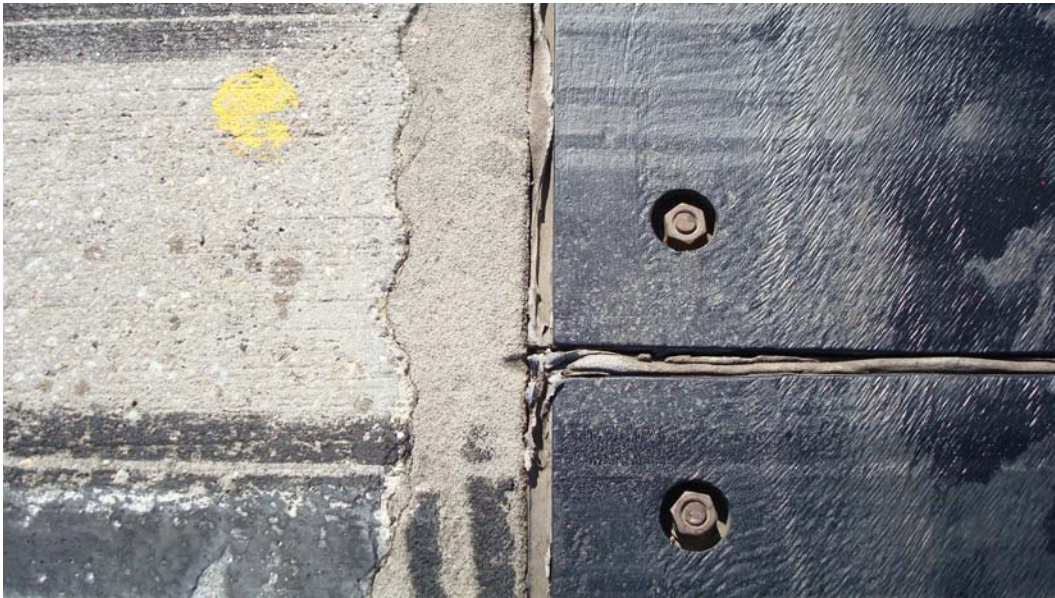
Figure 81. Repair of concrete adjacent to panels at Spangdahlem AFB.
